ADC TECHNICAL REPORT 54-159

## EVALUATION OF AN EXPERIMENTAL PLYWOOD-POLE LITTER

GEORGE W. HOGAN

AERO MEDICAL LABORATORY

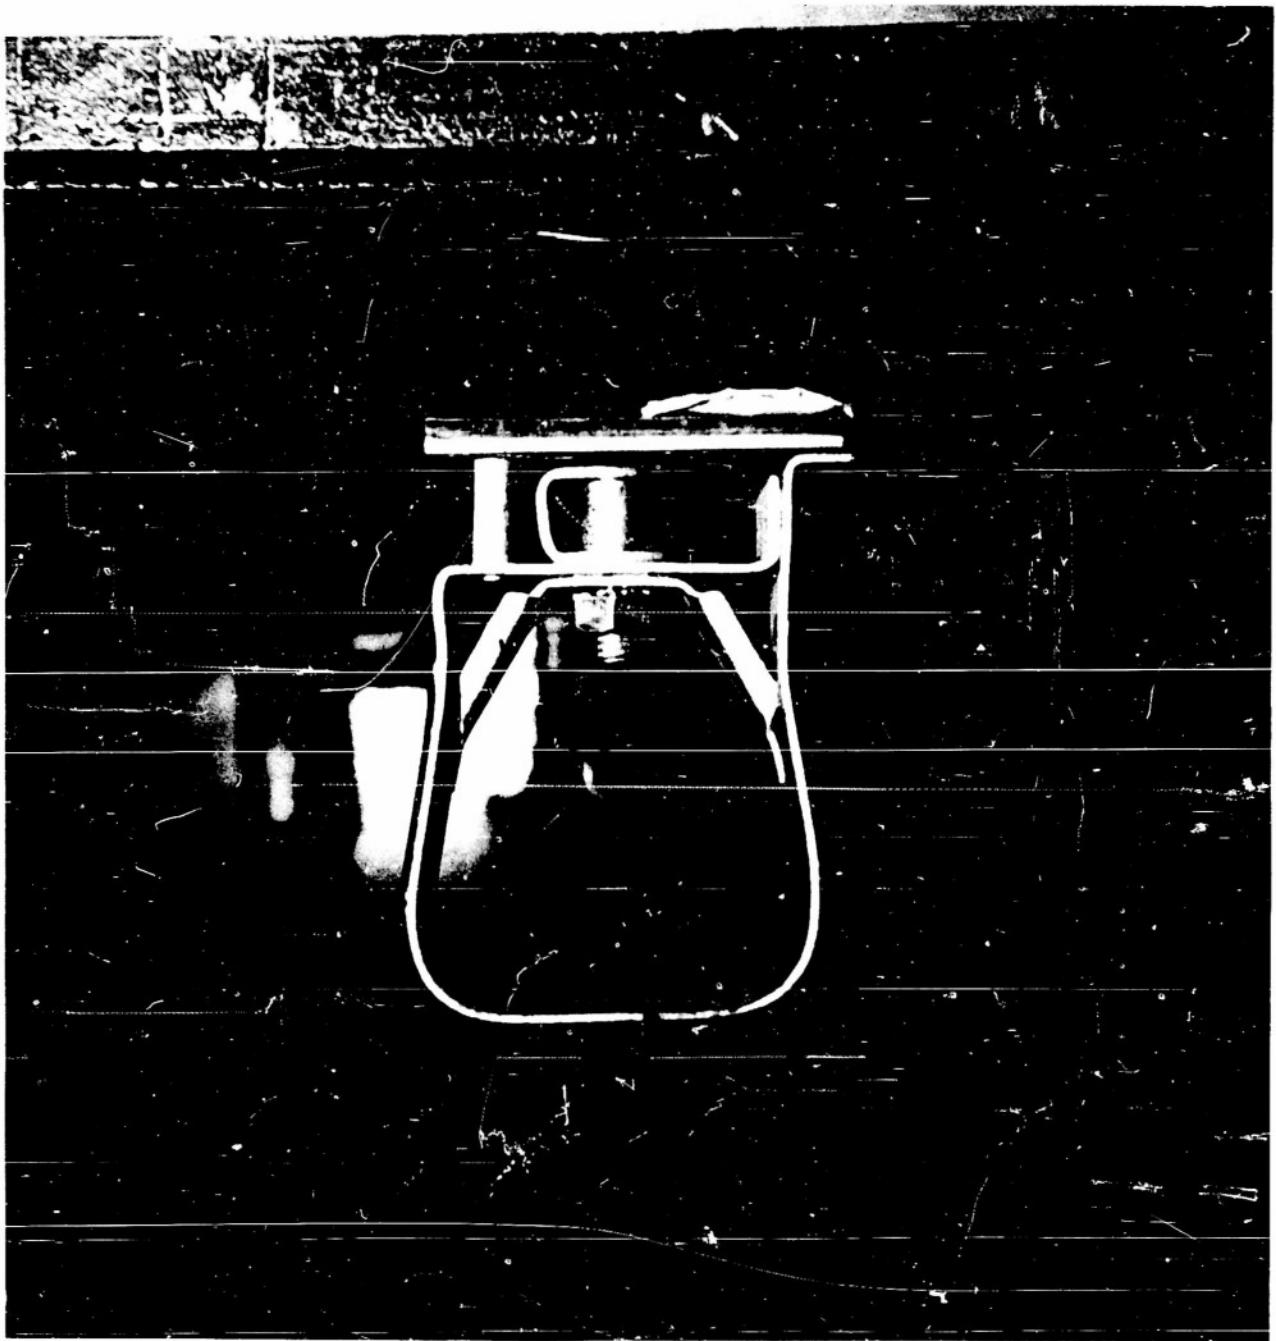
Figure 6

STIRRUP ASSEMBLY ALUMINUM POLE LITTER

Figures 5 and 6 show the typical stirrup assemblies of litters Nos. 1 and 3 respectively. Note the thinner material used for the stirrup of litter No. 3 (see Table I - Thickness of Stirrup Stock)

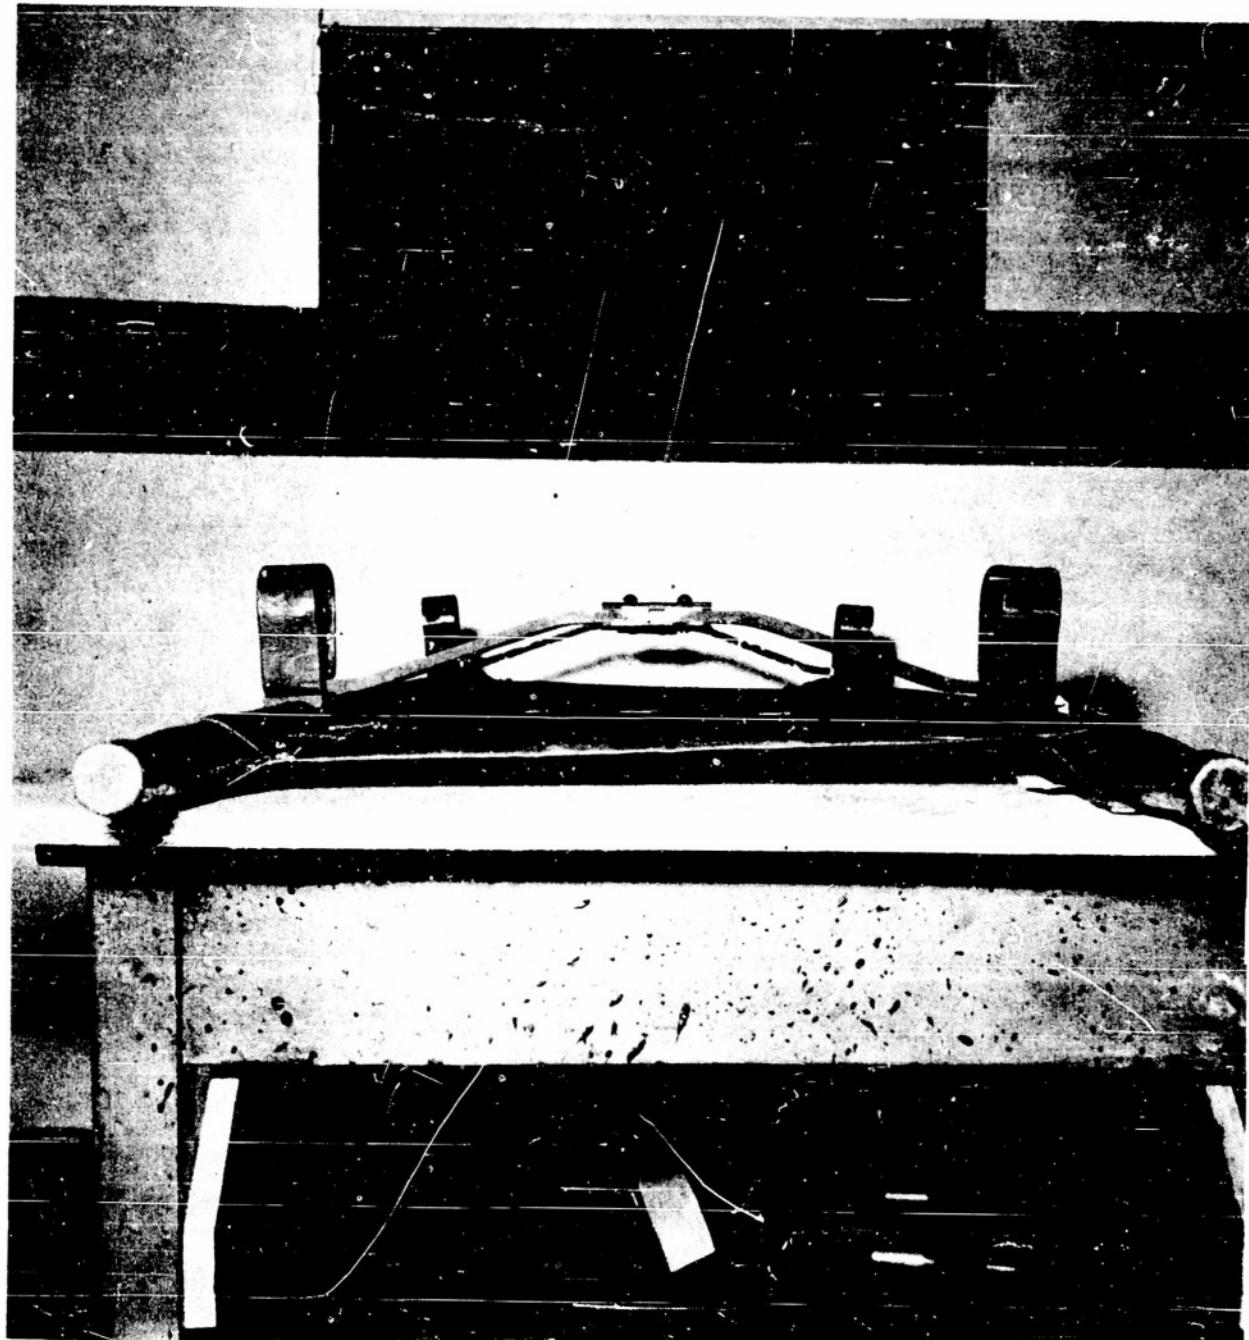
Figure 7  
END ON VIEW PLYWOOD POLE LITTER

Figures 7 and 8 are "end on" views of litters Nos. 1 and 3 respectively in the "upside down" position. Observe the corrugations on the stirrups and the channel-type construction of the spreader bars of litter No. 3. Also there is a coupler connecting the two spreader bars of litter No. 1 while a pin connects the spreader bars of litter No. 3. The "end on" view of litter No. 6 is similar to that of litter No. 1 excepting there is a taper to the stirrups of litter No. 6.

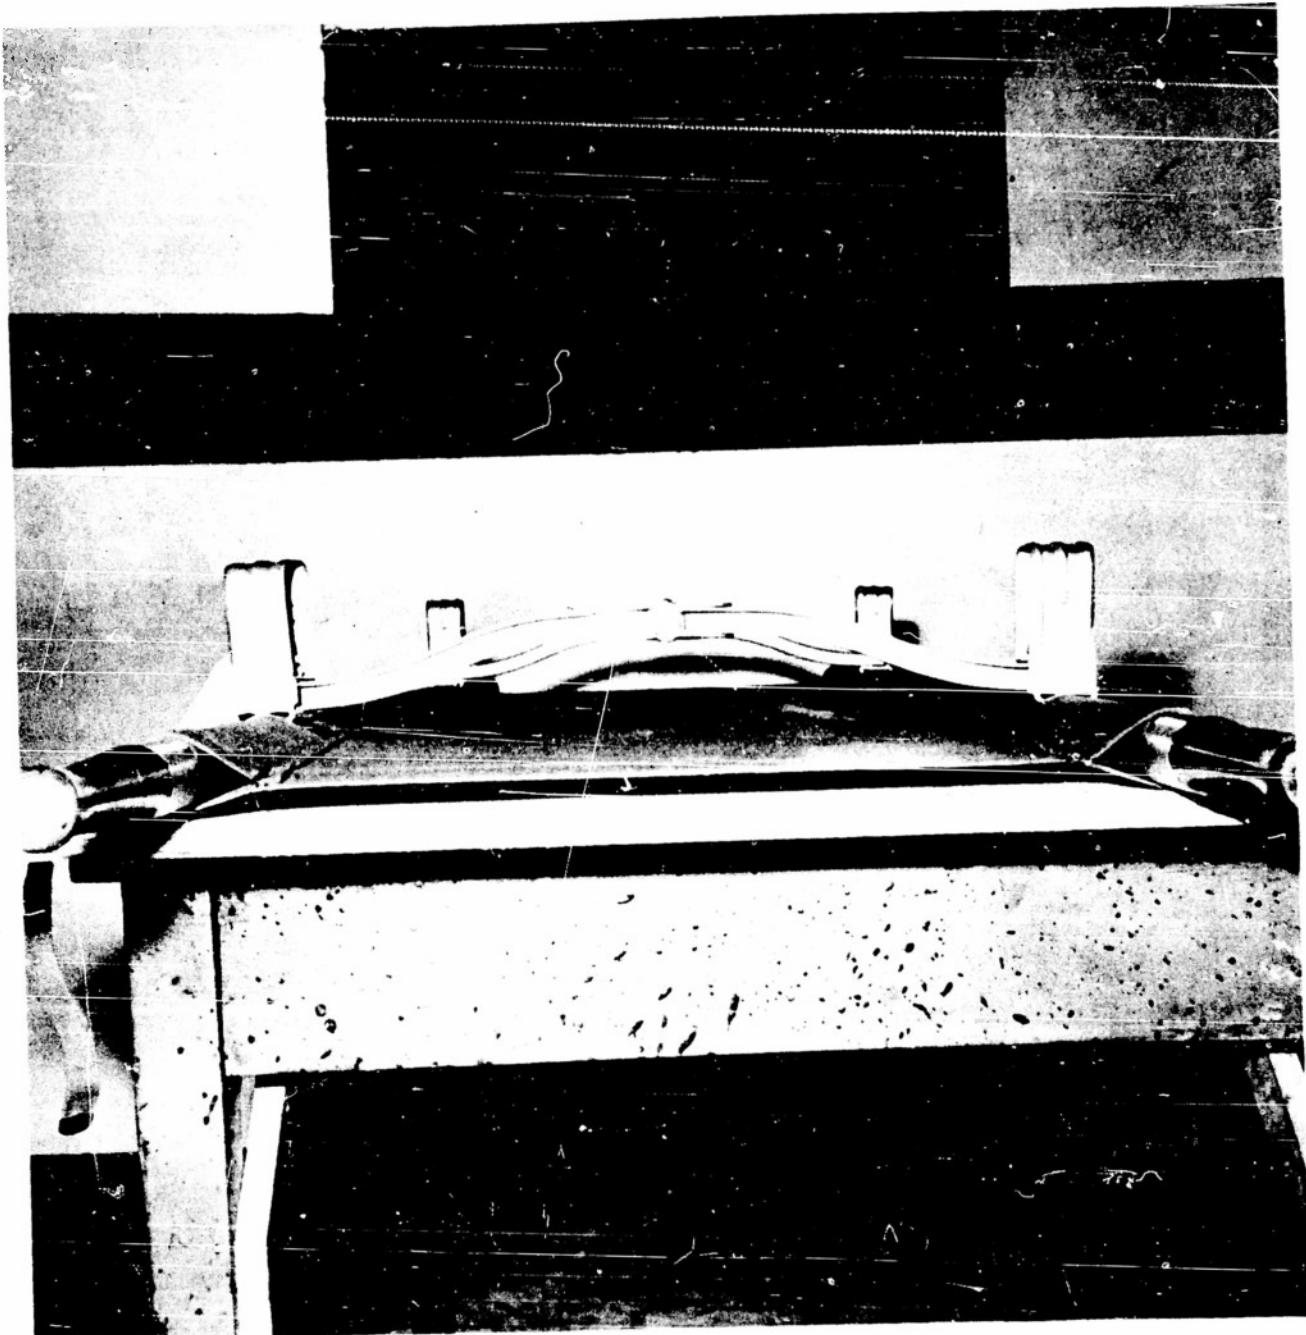
Figure 8

END ON VIEW ALUMINUM POLE LITTER

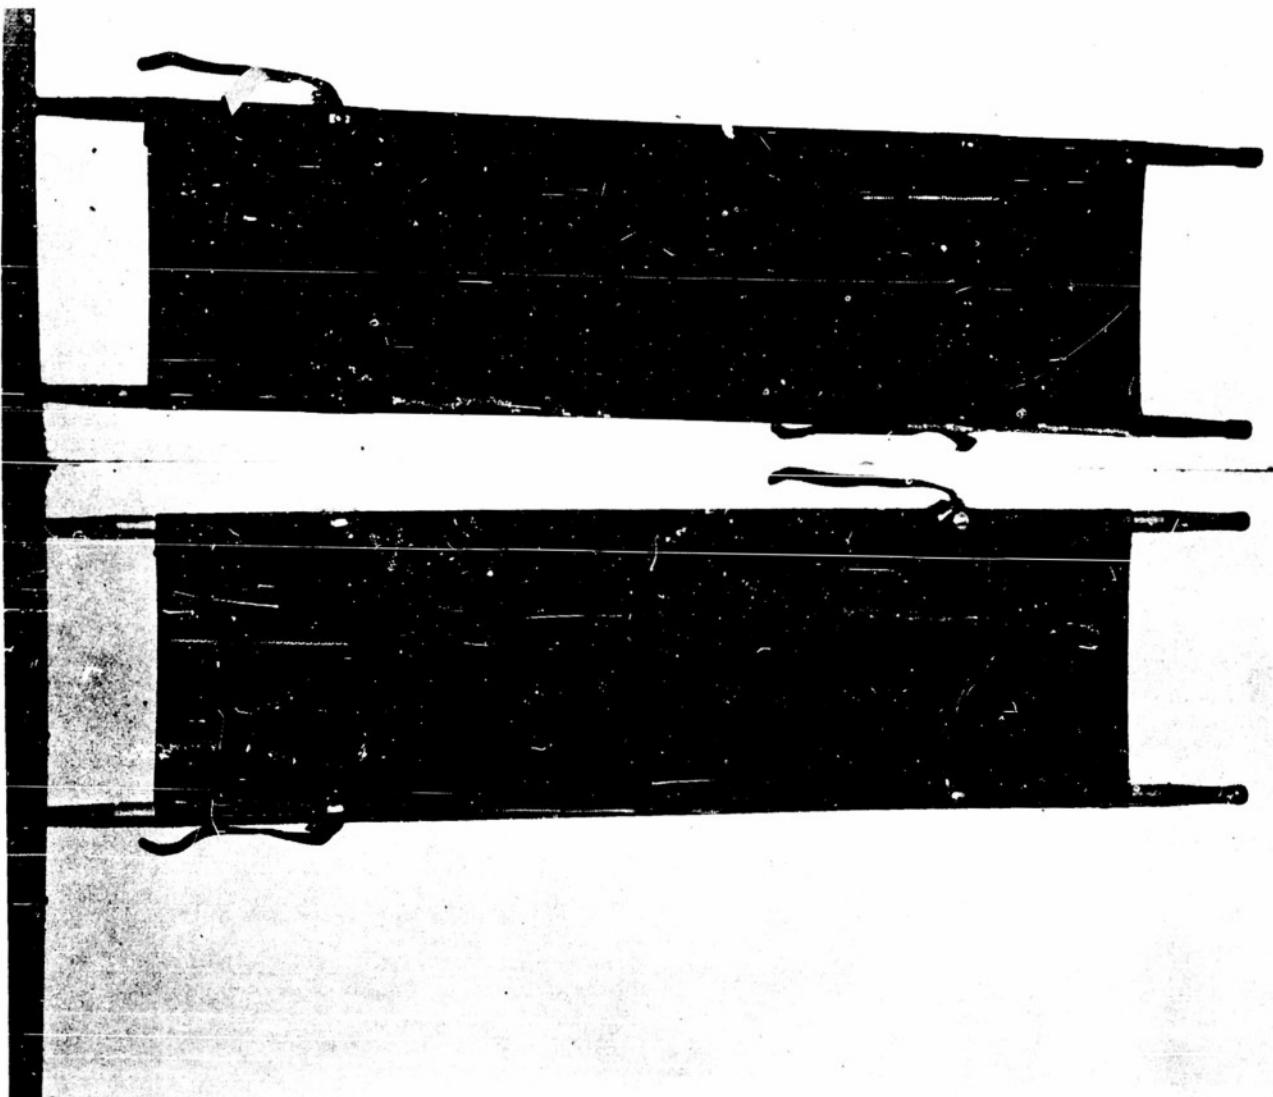
**Figure 9**

**TOP VIEW LITTERS**

Figure 9 is the "top" view of litters No. 1 (on the left) and No. 3. Note that there are no transverse fold lines on the canvas cover of litter No. 3.

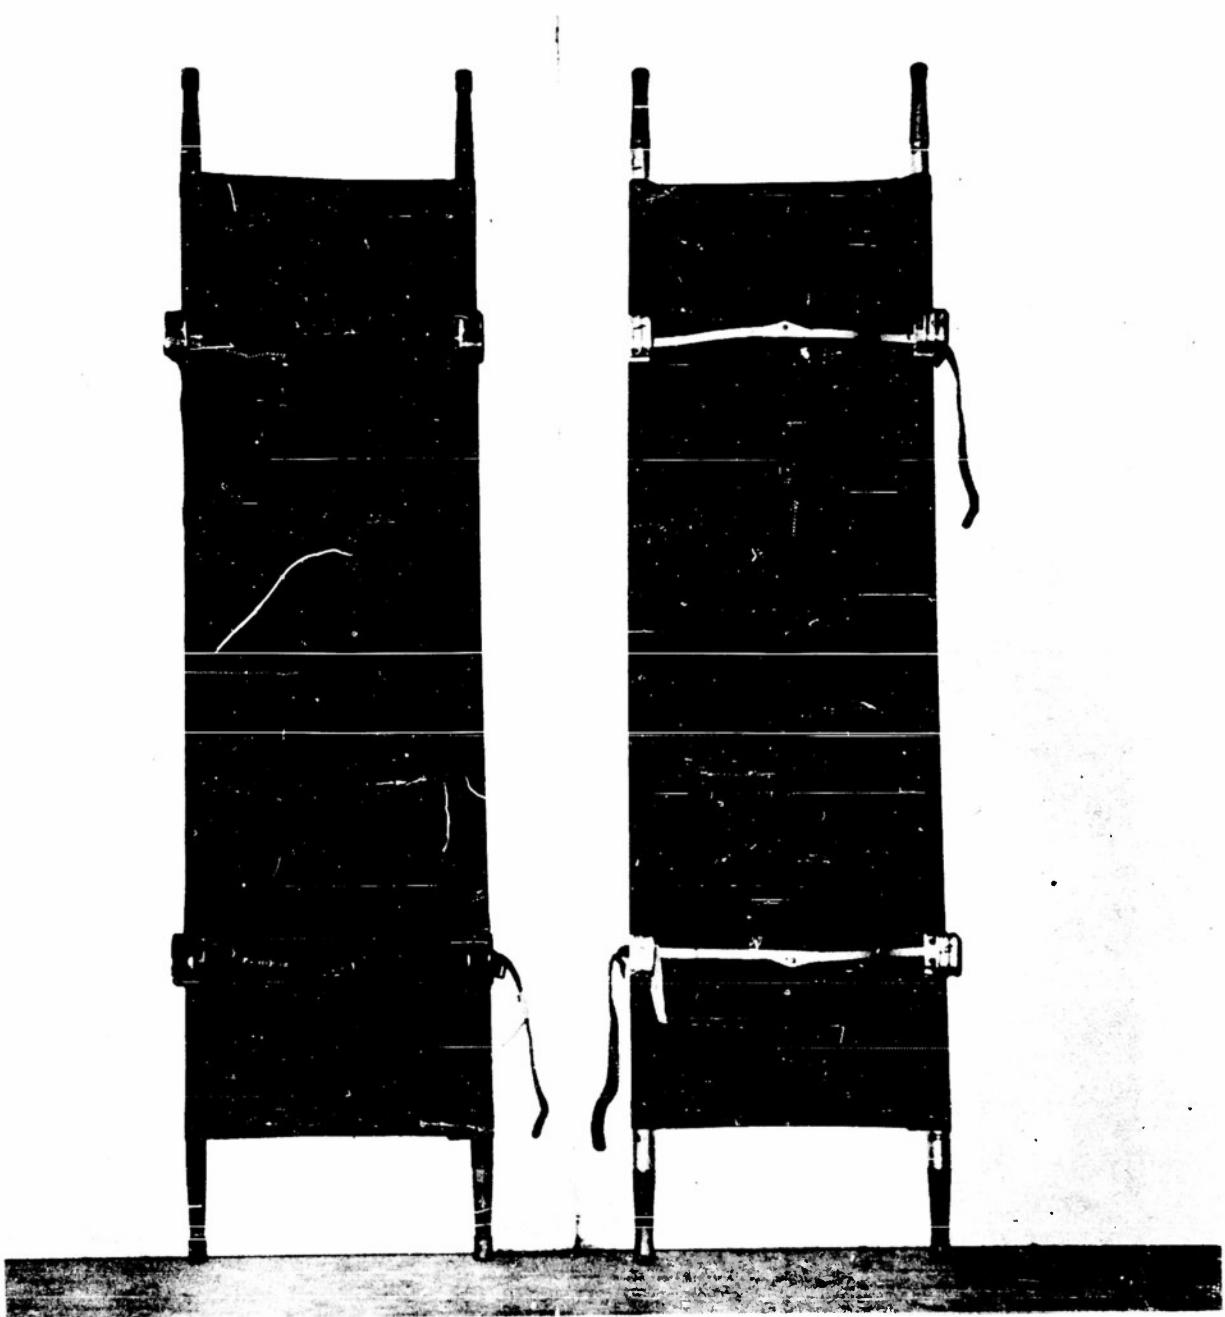
Figure 10  
BOTTOM VIEW LITTERS

Figure 10 is the "bottom" view of litters No. 1 (on the left) and No. 3. This view illustrates the method of numbering parts of the litters.

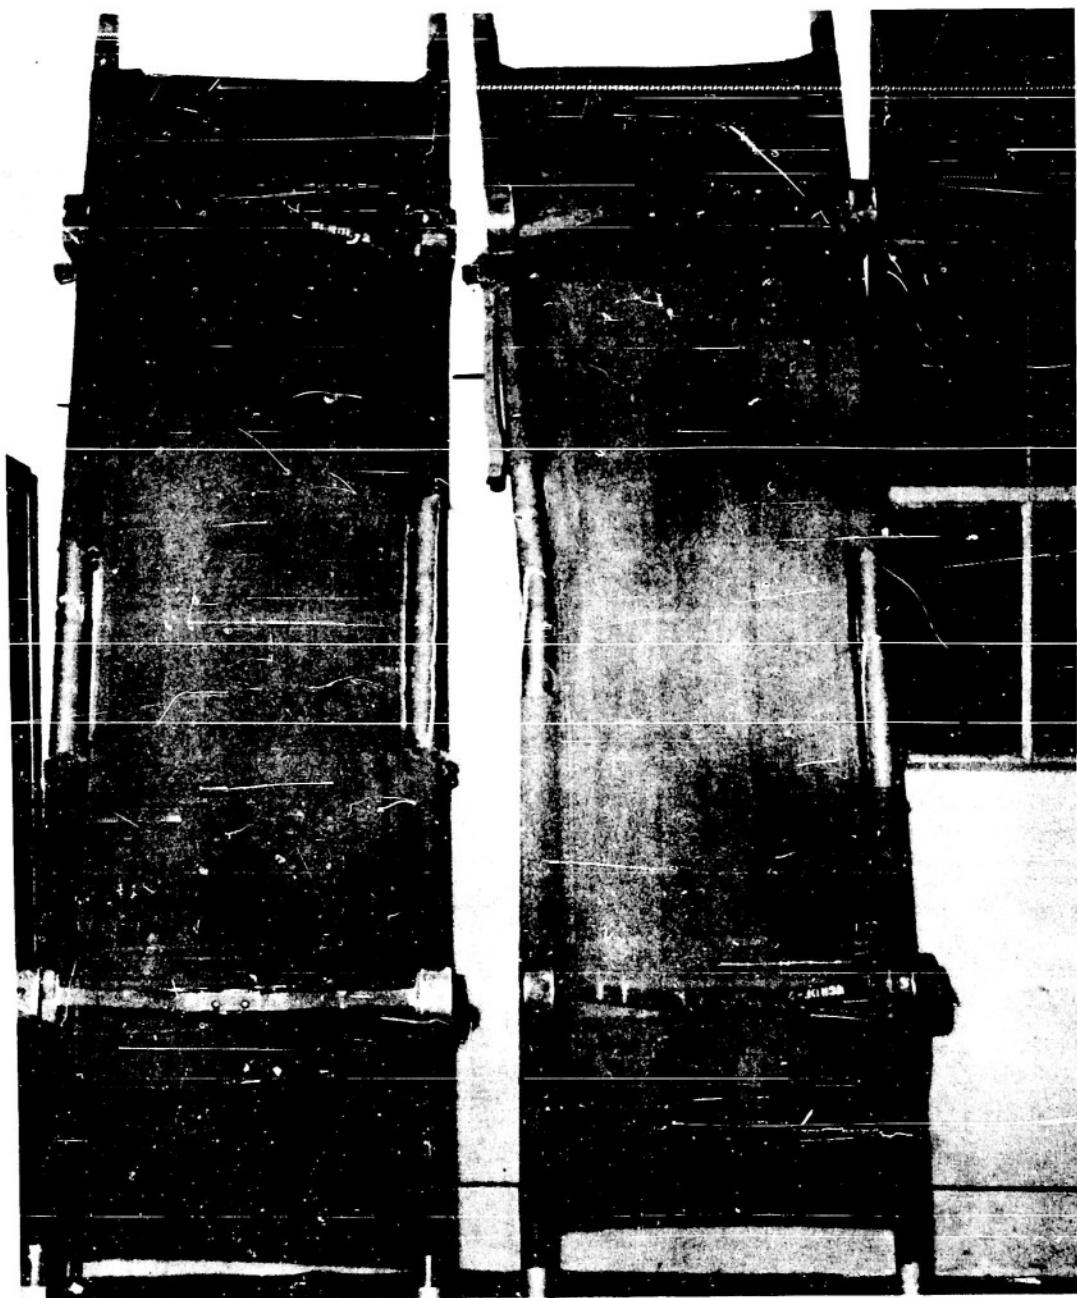
LITTERS No. 1 (ON THE LEFT) AND No. 2  
AFTER "ULTIMATE STRENGTH" TEST

Litter No.	Initial Load (lbs.)	Final Load (lbs.)	Failure
1	920	920	Poles 1-2 and 3-4 broke. The fracture was characterized by longitudinal cracks and delamination.
2	1000	1090	Same as litter No. 1.
3 *	1440	1440	Pole 1-2 collapsed. Pole 3-4 showed a severe permanent set.
4	1000	1760	Pole 3-4 collapsed. Pole 1-2 showed a severe permanent set.
5	1000	1390	Failure similar to that of litter No. 4.
6	1000	2050	Failure similar to that of litter No. 4 but more severe. Also, wood handle No. 3 was abraded.

Figure 11 shows failures of litters No. 1 (on the left) and No. 2 near the pole centers. (The canvas has been removed from near the failures so that the nature of the breaks can be observed). Note the long cracks on several of the failures.

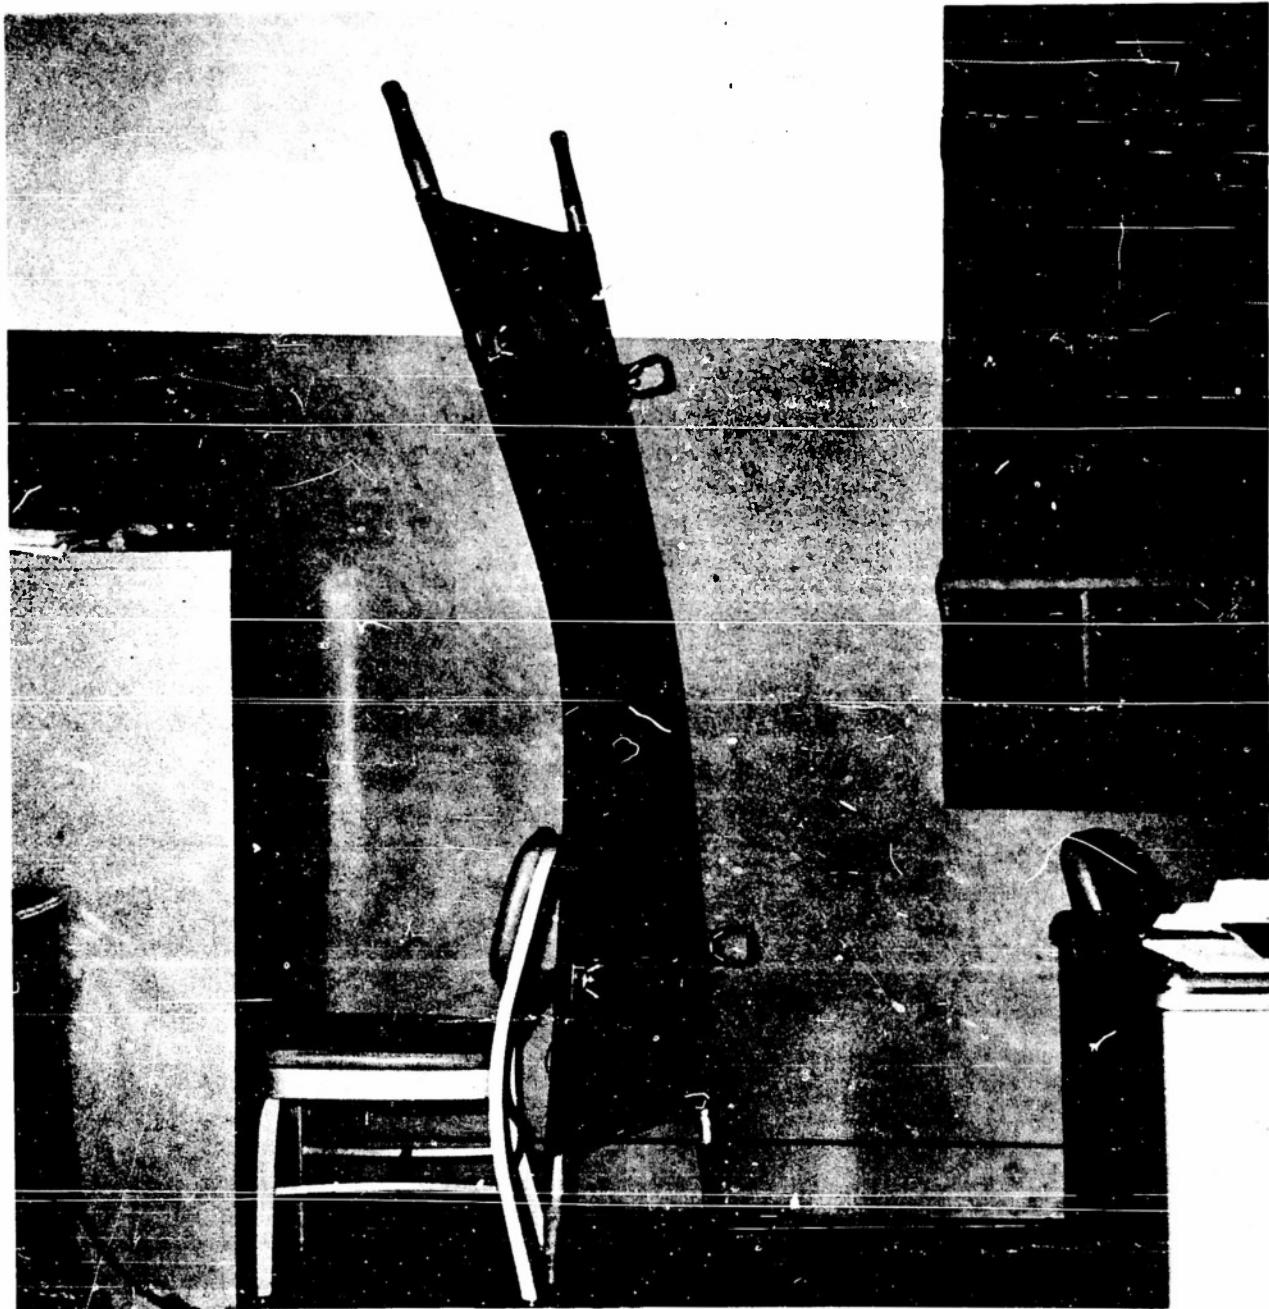
Figure 13  
LITTER No. 3 AFTER "ULTIMATE STRENGTH" TEST

Figures 13, 14, 15 and 16 show the collapsed poles of litters Nos. 3-6 respectively. Note the permanent sets in the other poles.

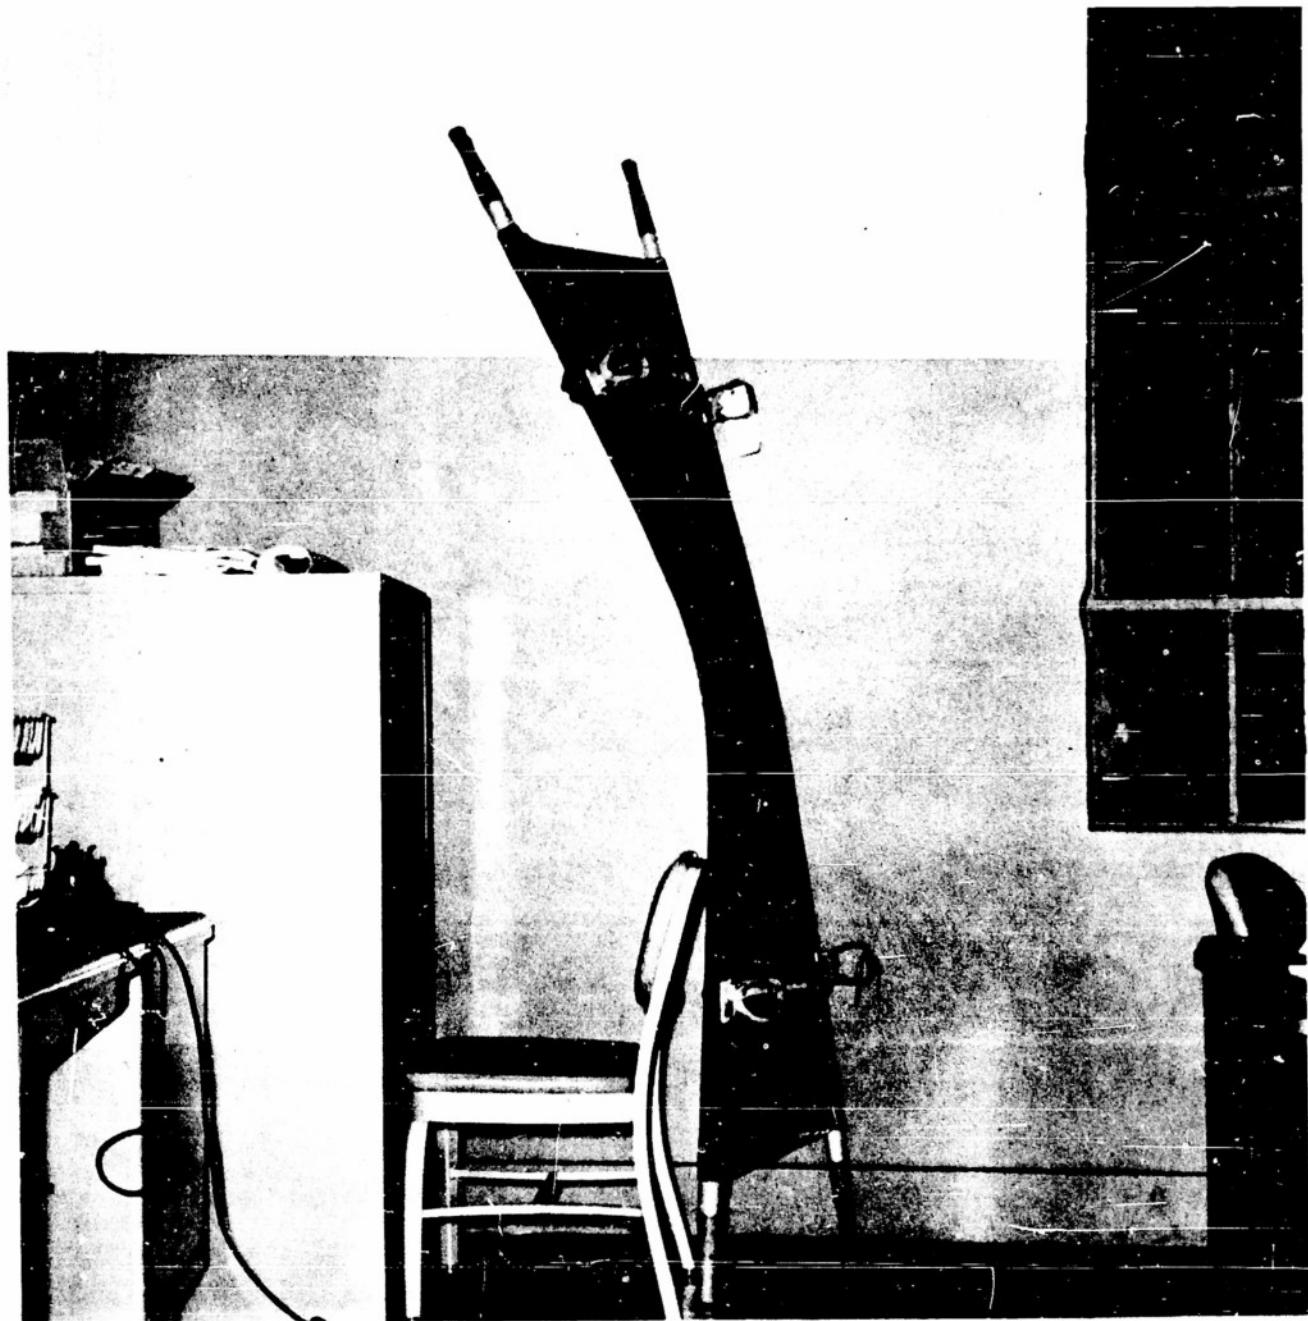
Figure 14

LITTER No. 4 AFTER "ULTIMATE STRENGTH" TEST
